# Minidoka Irrigation District

## Project Spotlight

### B2 Check Structure Rebuild

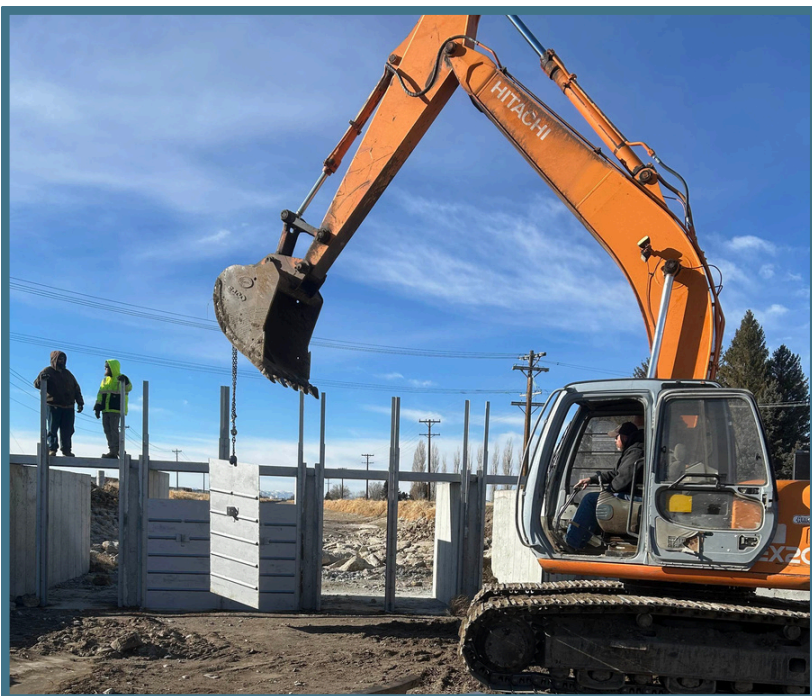
*MID crews install new gates on the B2 Check Structure*

As part of the upgrades, the existing ratchet gates were replaced with screw gates to improve functionality and reduce employee strain and risk of injury during operation. Automated water-measurement devices were also installed to increase accuracy and efficiency, allowing water levels to be maintained more consistently and improving overall system performance.

Phase 2 included the primary construction work, with crews forming the structure, pouring concrete, and installing the new gates. Care was taken throughout this phase to ensure accuracy and long-term durability.

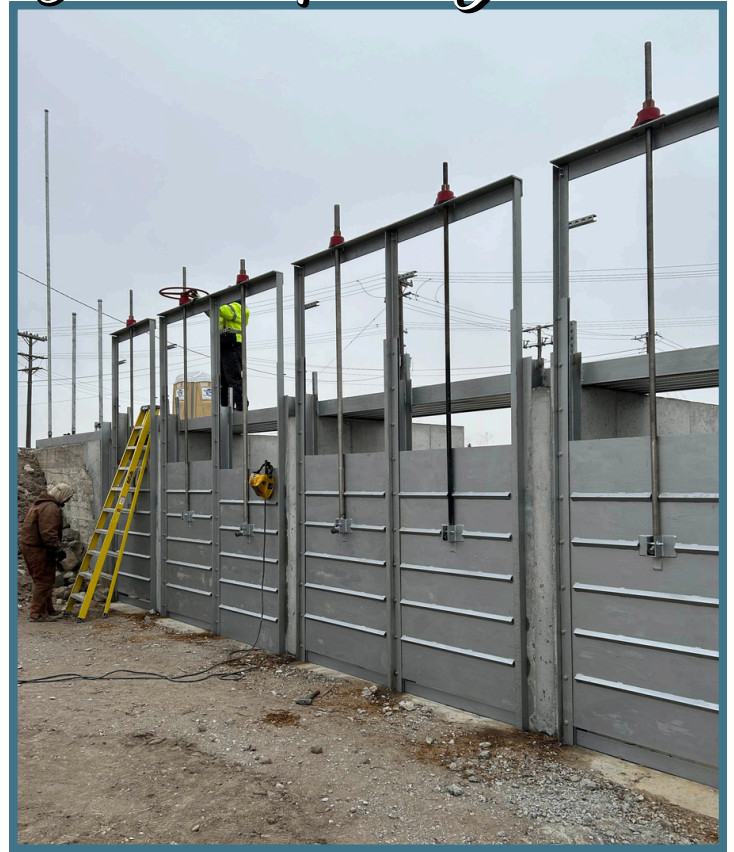
*The new gates at the B2 Check Structure.  
The gates are 6' tall*
